Technical Memorandum

LSNA Hydrologic Analysis

TO: Mr. Peter Guillozet, Project Manager
Luckiamute Watershed Council

SUBJECT: Hydrologic Analysis and Recommendations for the Luckiamute State Natural Area

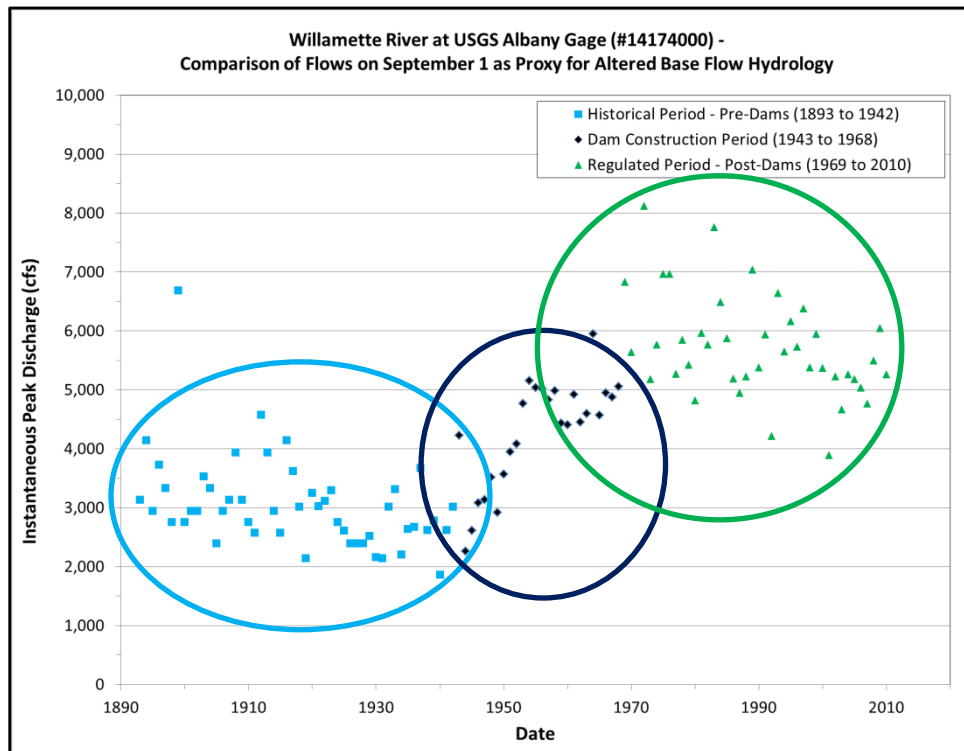
Figure 2-3. A comparison of the mean daily flow on September 1 for each year in the three river management periods as a proxy for summer base flow changes over time in respect to flood control operations in the Willamette River basin.

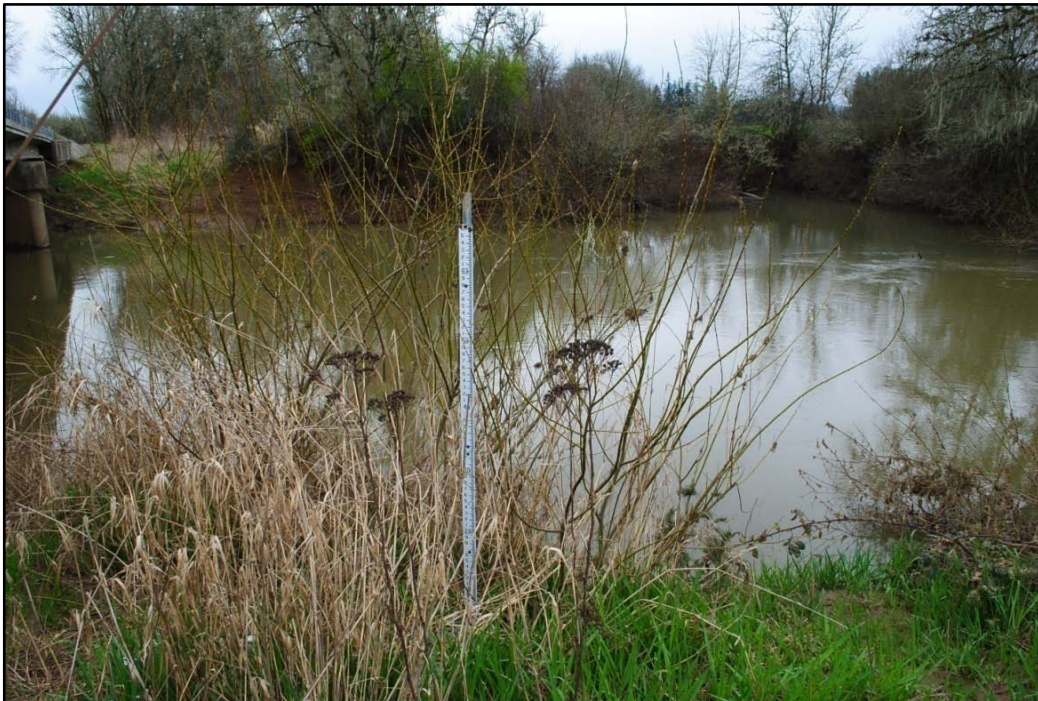
Figure 2-5. Staff Plate #3 near the confluence of Soap Creek and the Luckiamute River.

- Selected staff plate location.
- Dug a 1 ft deep by 1 ft wide hole with a post hole digger.
- Drove the 2 inch by 10 ft metal conduit pole into the hole approximately 2 ft using a post driver.
- Poured concrete into the 1 ft hole to anchor conduit pole.
- Fixed three sections of 3 ft tall staff plates to conduit with sheet metal screws.
- Used GNSS GPS unit to survey a minimum of two measurement increments on the bottom staff plate to establish real-world elevation at each staff plate.

Figure 2-5 includes a photo of a completed staff plate.

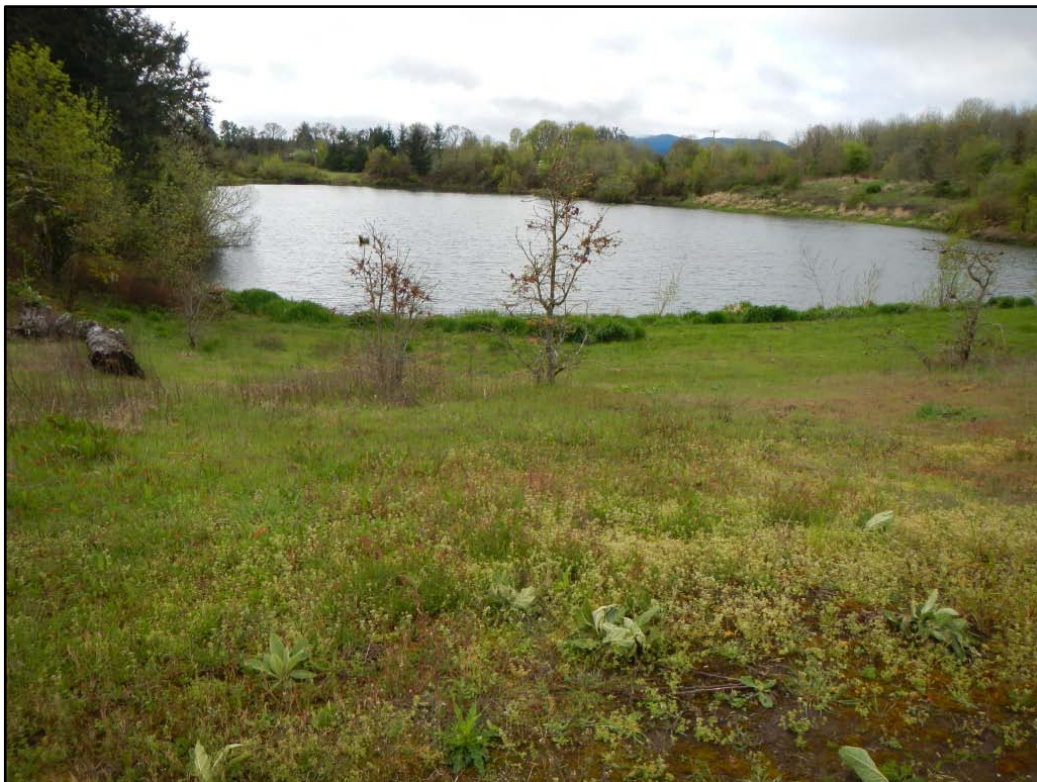
Figure 4-1. The west pond at the South Tract is a sink for fish moving from the Willamette River into the interior floodplain during high flows. The berm surrounding the pond also limits connection between the river and floodplain. The photo is a view south from SIA #9.

As an example, at the LSNA South Tract, the west pond embankments act as a barrier until approximately 43,500 cfs (~2 weeks/year), limiting flood flows from connecting the swales to the east and west of the pond. Figure 4-1 shows the west pond and the surrounding embankments. As high flows connect this area of the floodplain to the Willamette River, fish access floodplain areas for food resources and to escape high velocities and turbulence present in the main channel. As flows begin to recede, fish returning to the main channel from floodplain margins could be drawn to the deep water in the west pond and become trapped as the pond disconnects from the rest of the floodplain and river. Fish trapped in the pond would be subjected to poor water quality and predation.

By excavating the areas at SIAs #9 and #10 to the existing floodplain elevation, the floodplain areas of the west pond and west swale would become connected on a more frequent basis, at approximately 36,000 cfs (3-4 weeks/year). Because the bottom of pond elevation is lower than the surrounding floodplain, fish stranding in the west pond could still be an issue. Additional

floodplain grading could be completed to the north of the pond with the excavated material used to fill the pond to a more natural floodplain elevation. This would not only increase the acreage of inundated floodplain, but would reduce stranding issues for native fish. However, the amount of fill necessary to grade the pond to create a natural floodplain feature may be cost prohibitive. Also, competing interests with this type of project are present at the west pond site and may affect the feasibility of this type of project. Currently a variety of wildlife use the west pond, including western pond turtles which are on the Oregon Department of Fish and Wildlife's (ODFW) Sensitive Species list. Recreational uses such as bird watching and fishing are also common activities at the west pond.

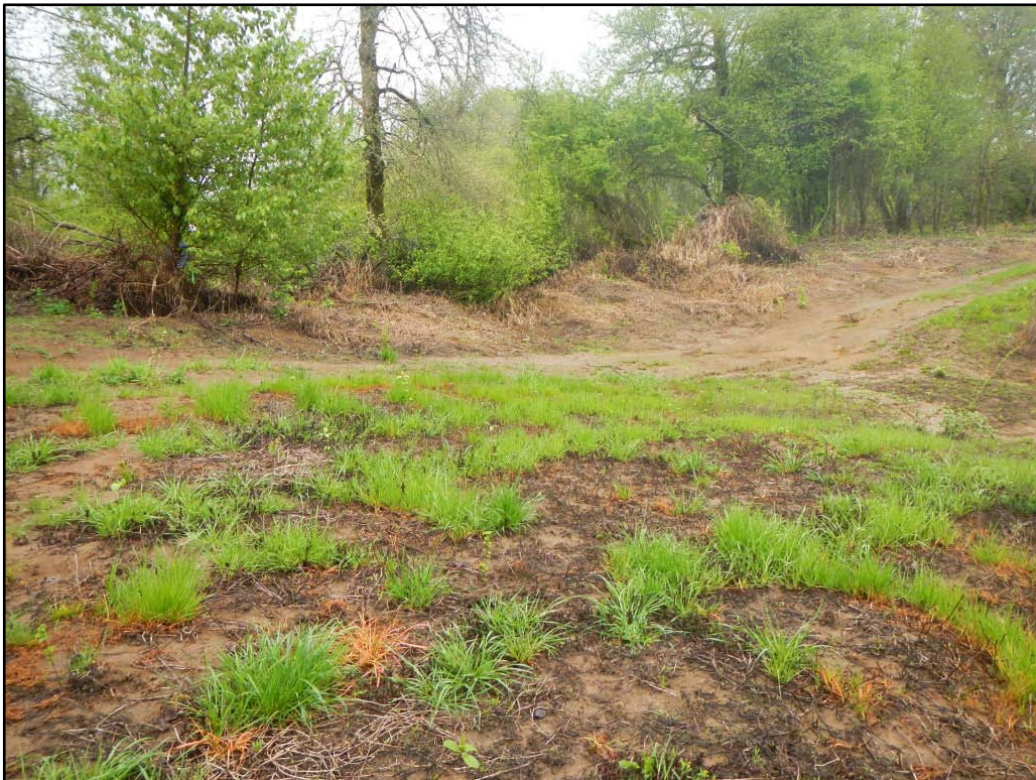
Figure 4-2. At SIA #8, the existing access road is set at the same elevation as the invert of the swale. The bank elevation could be lowered slightly to allow floodwater to access the swale and the pond located to the north.

At the LSNA North Tract, most access roads are located at the existing floodplain elevation and do not adversely impact site inundation potential. Two sites located at SIAs #7 and #8 could have minor bank modifications that would allow swales to connect with the Willamette River at slightly lower flows than under current conditions. Bank modifications would require a small amount of excavation to lower the existing top of bank elevation, and the installation of large wood structures could be used to increase the modified bank stability. Additional habitat structures could be constructed within swales to provide higher quality habitats.

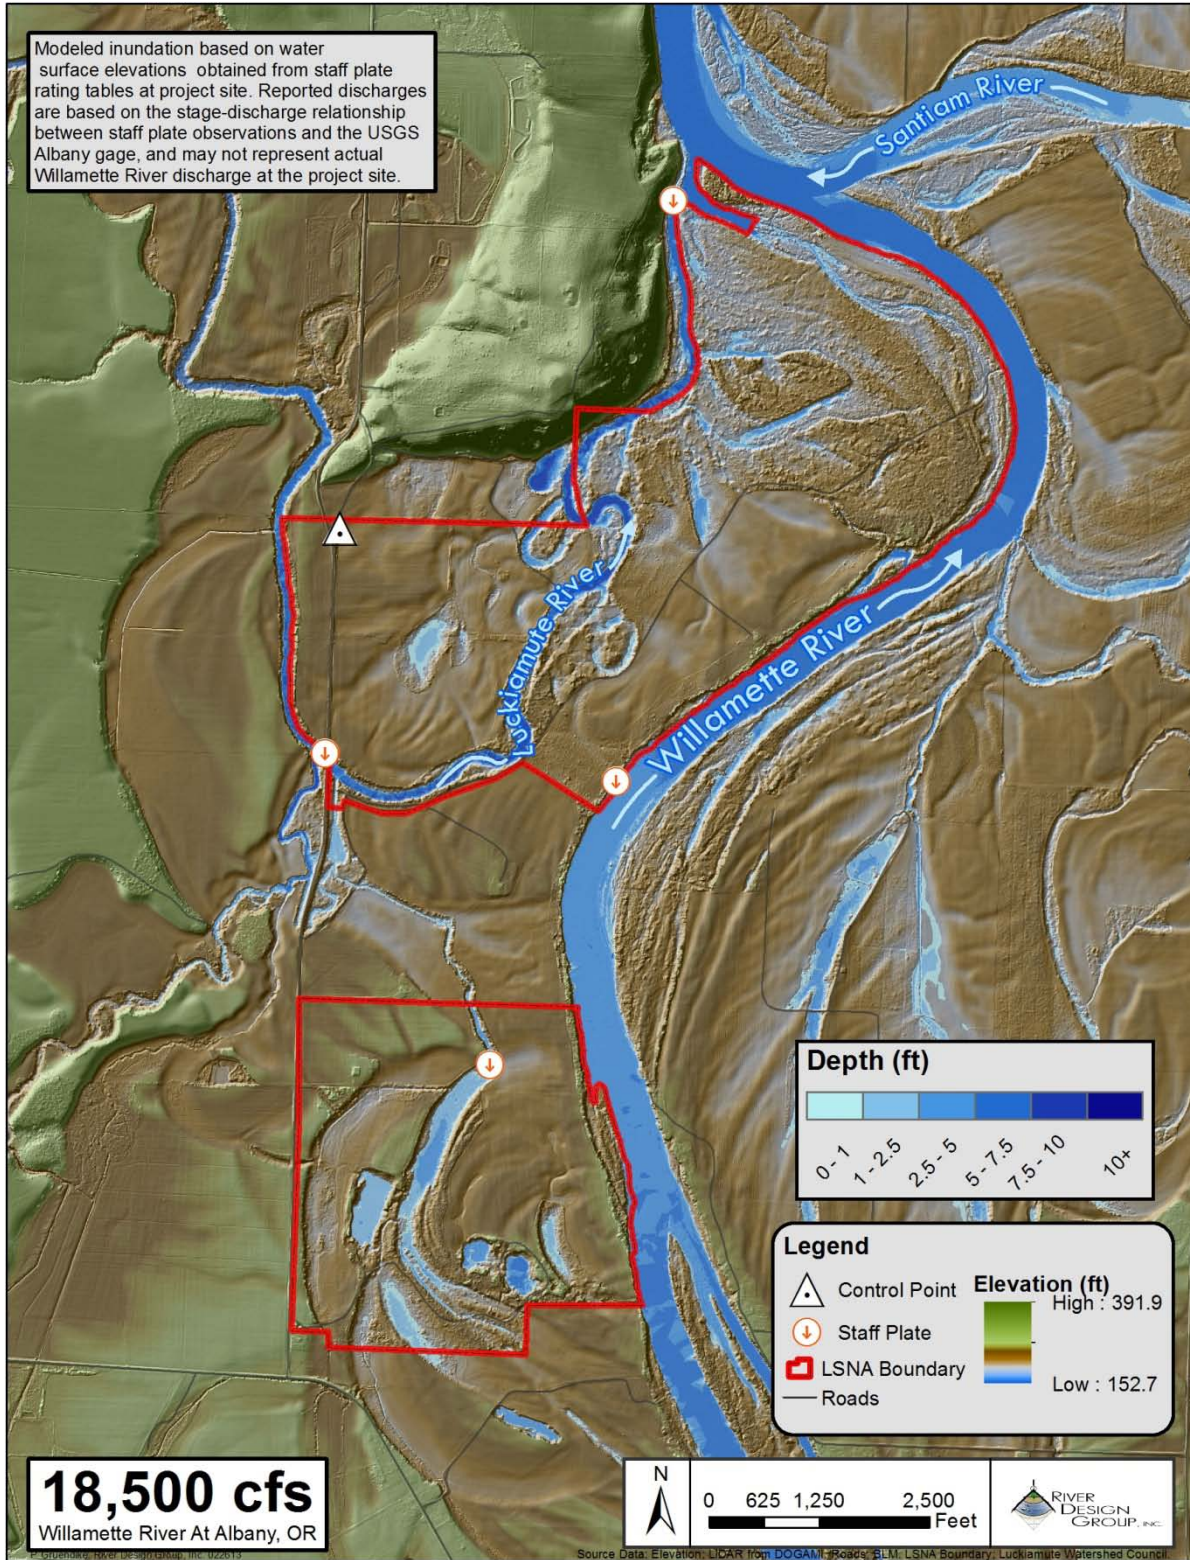
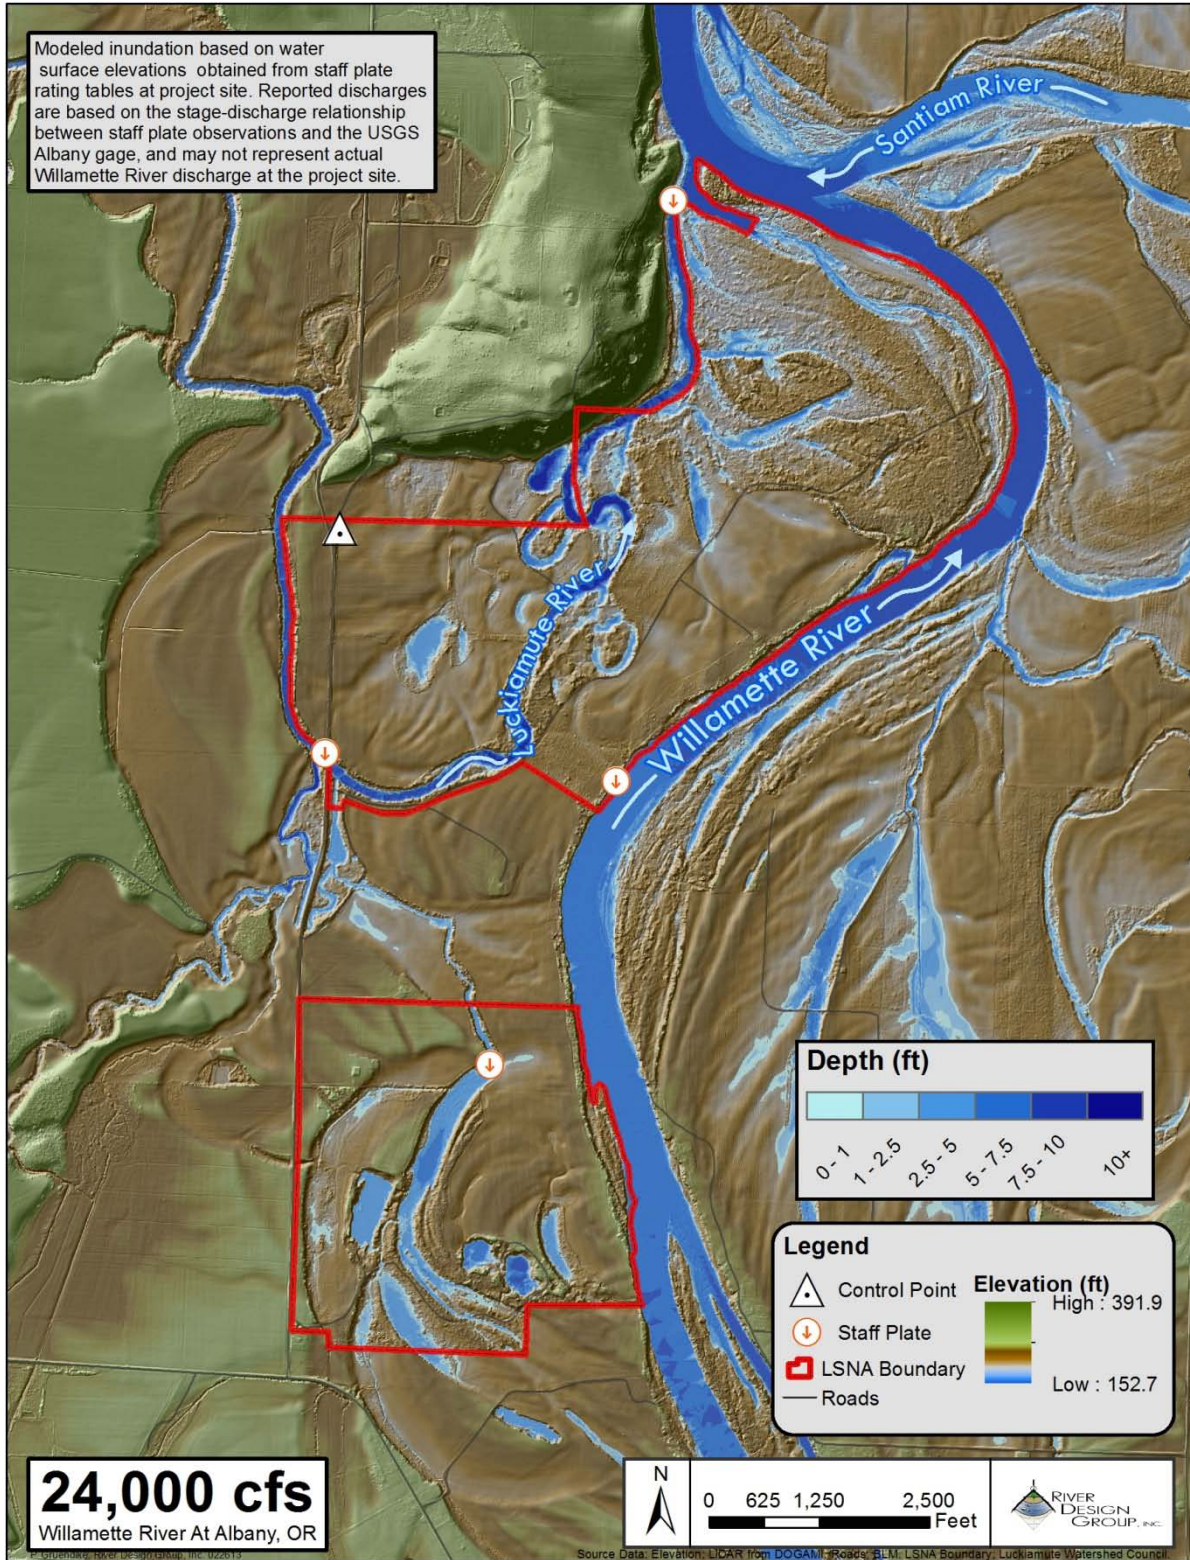
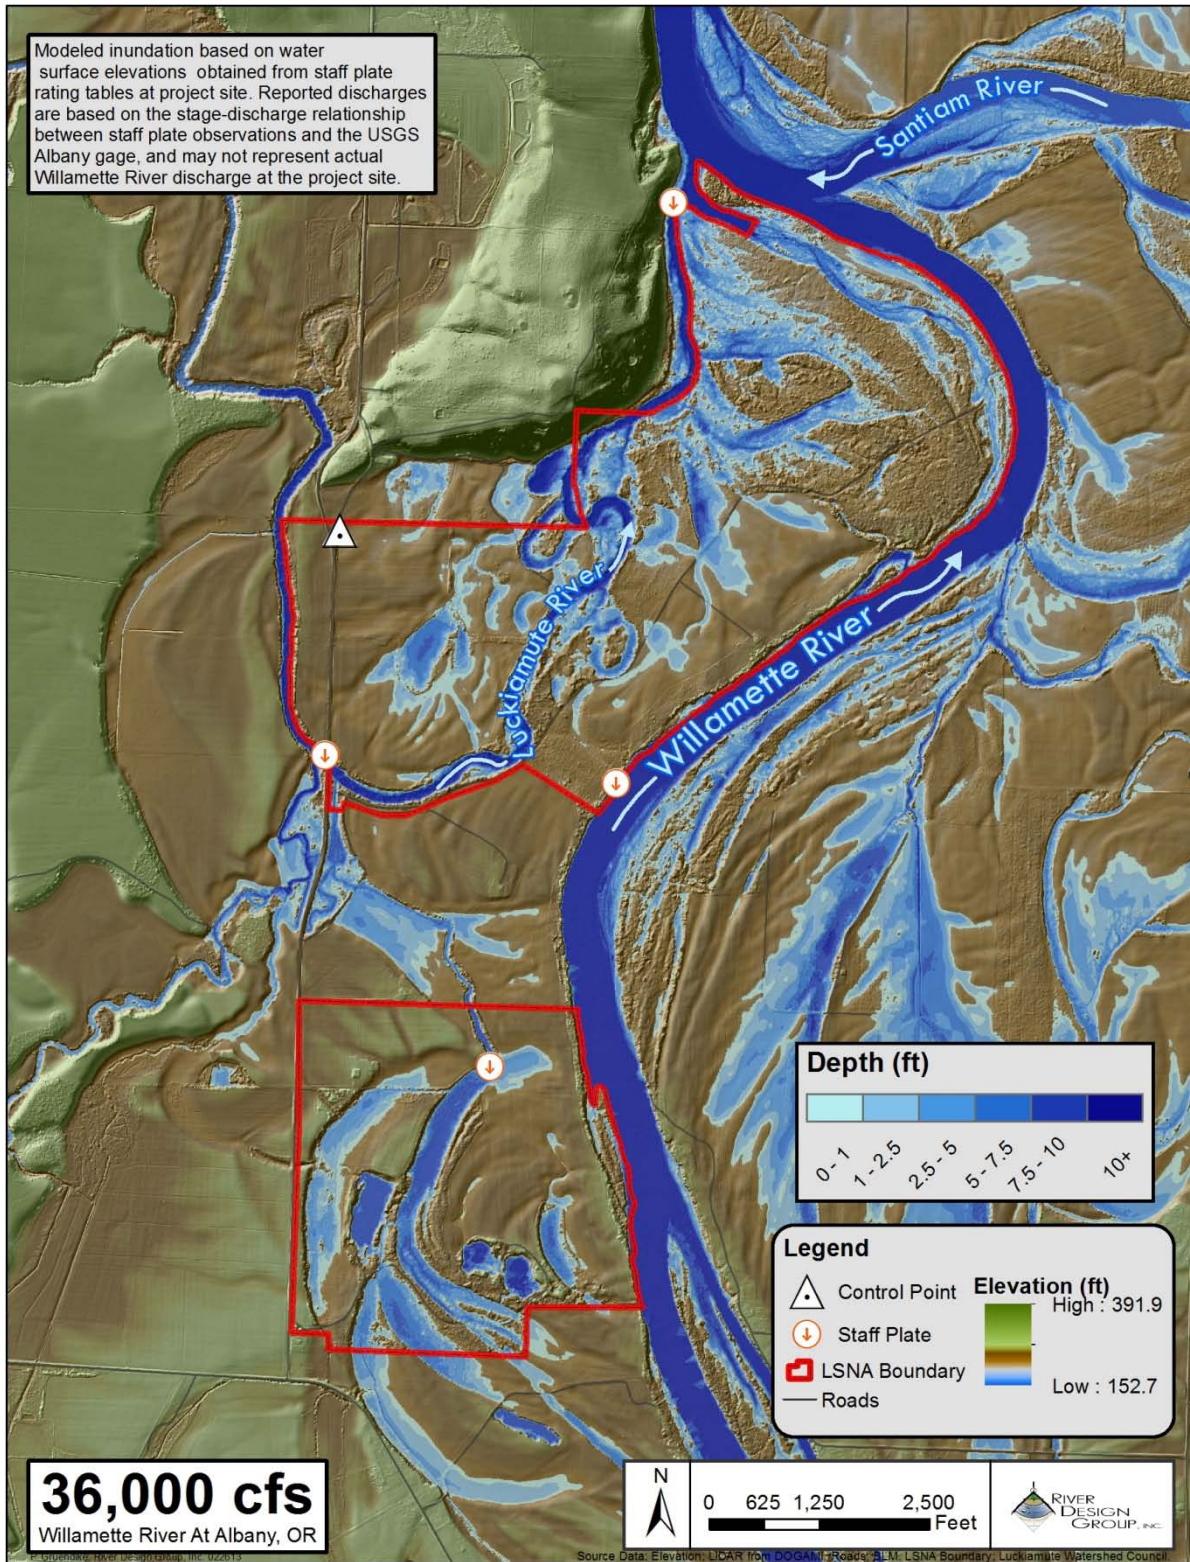
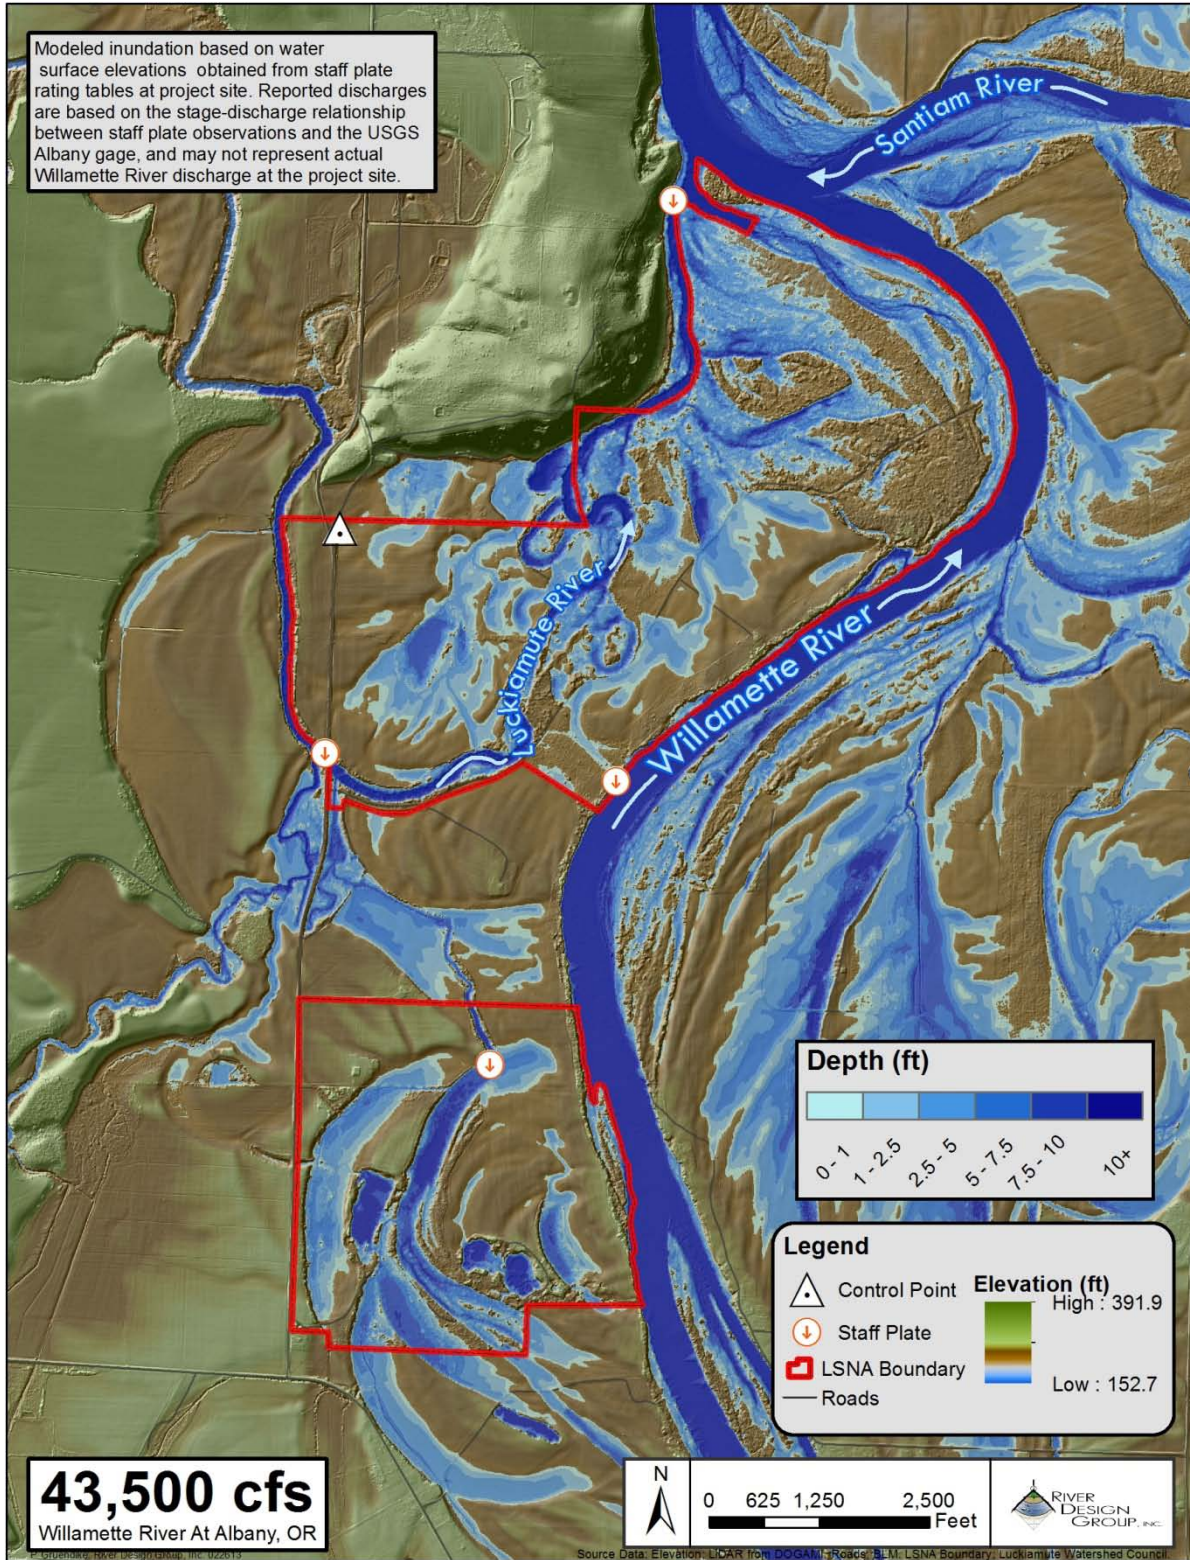
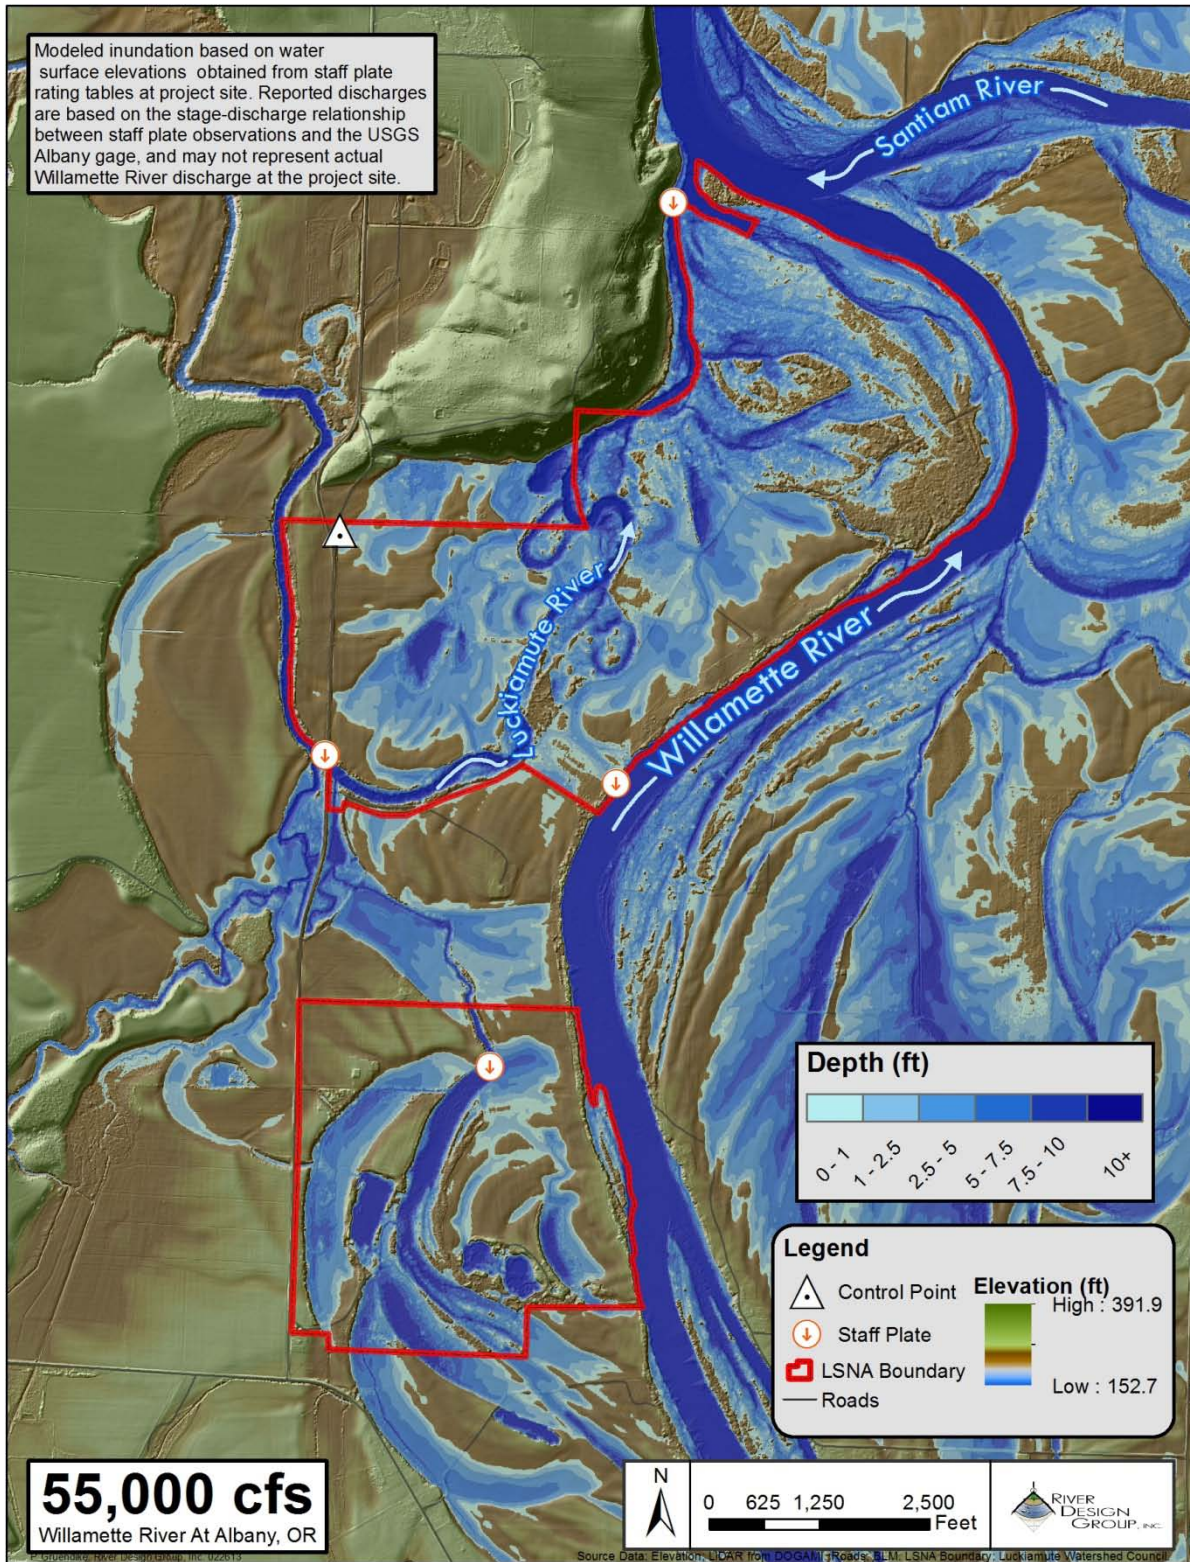
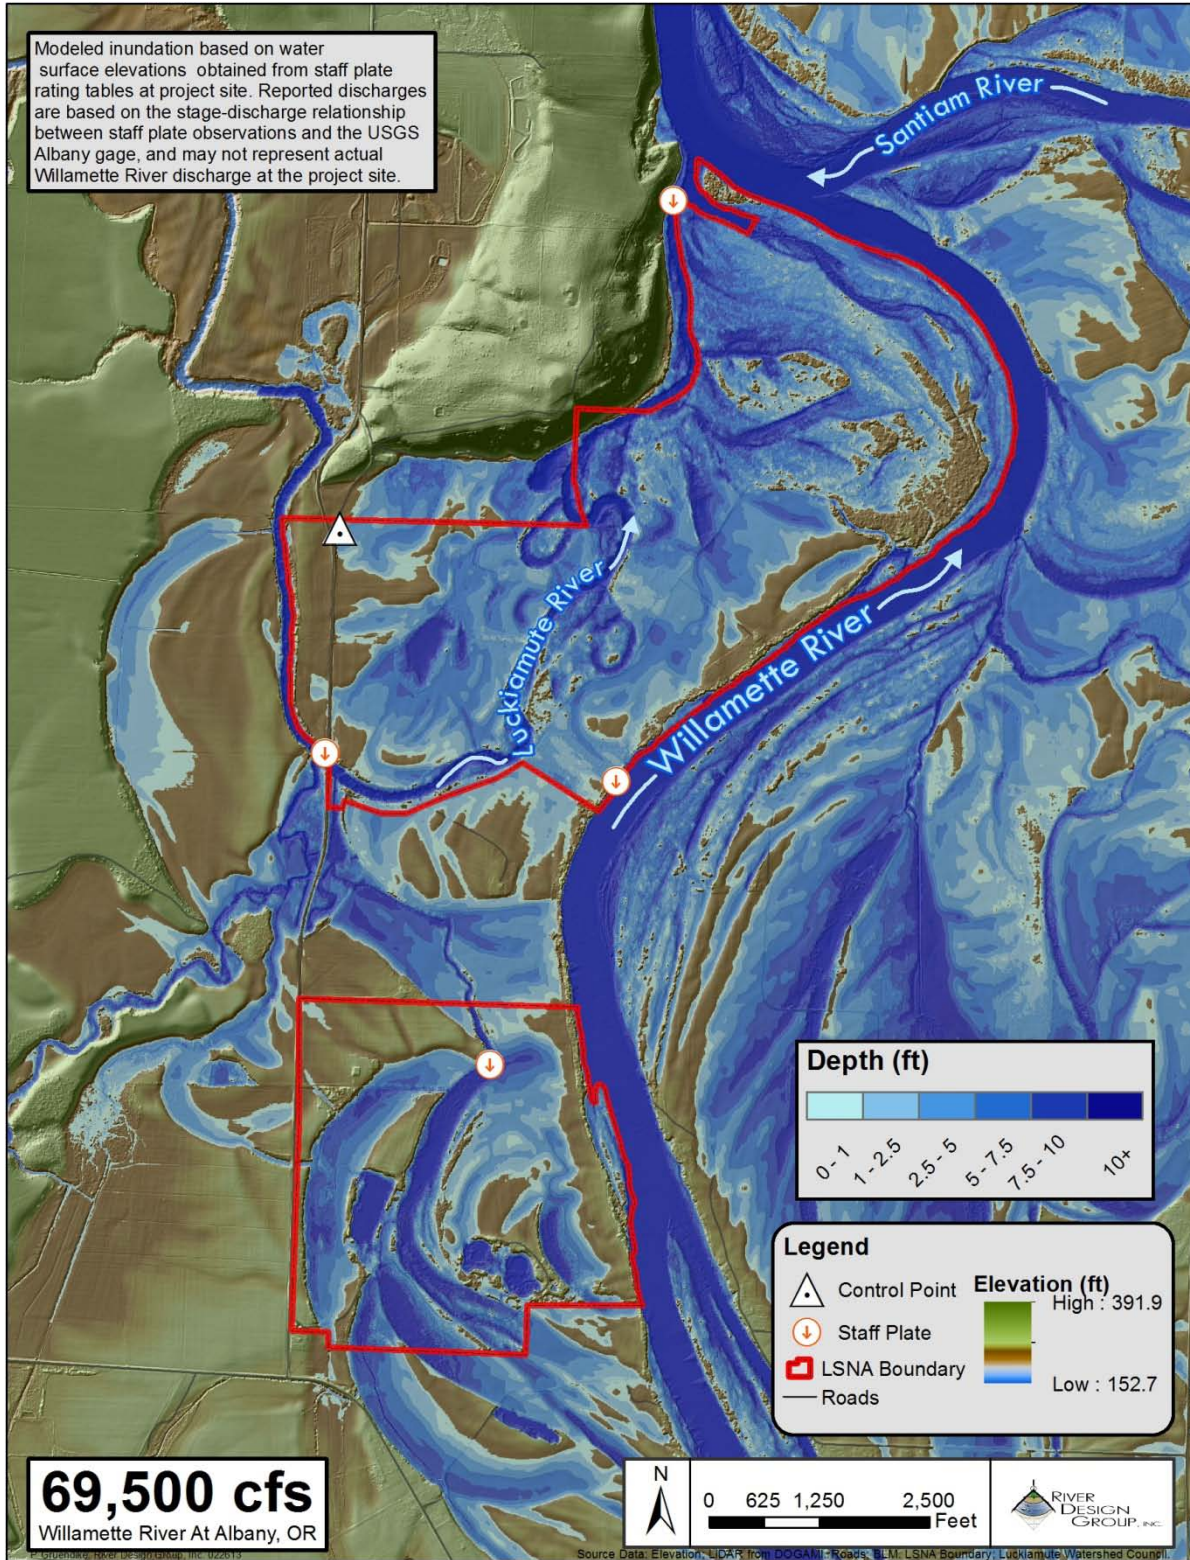
APPENDIX A
LSNA INUNDATION MAPS

Full page maps are also included in Appendix A. The maps show potential floodplain inundation extents with increasing Willamette River discharge. This information is informative for predicting floodplain inundation associated with restoration actions that increase connectivity between the Willamette River and the adjacent floodplain in the LSNA area.
